## **Notice of Completion of Closure**

### **Hoot Lake Plant Ash Landfill**

## Hoot Lake Ash Landfill 2023 Final Closure

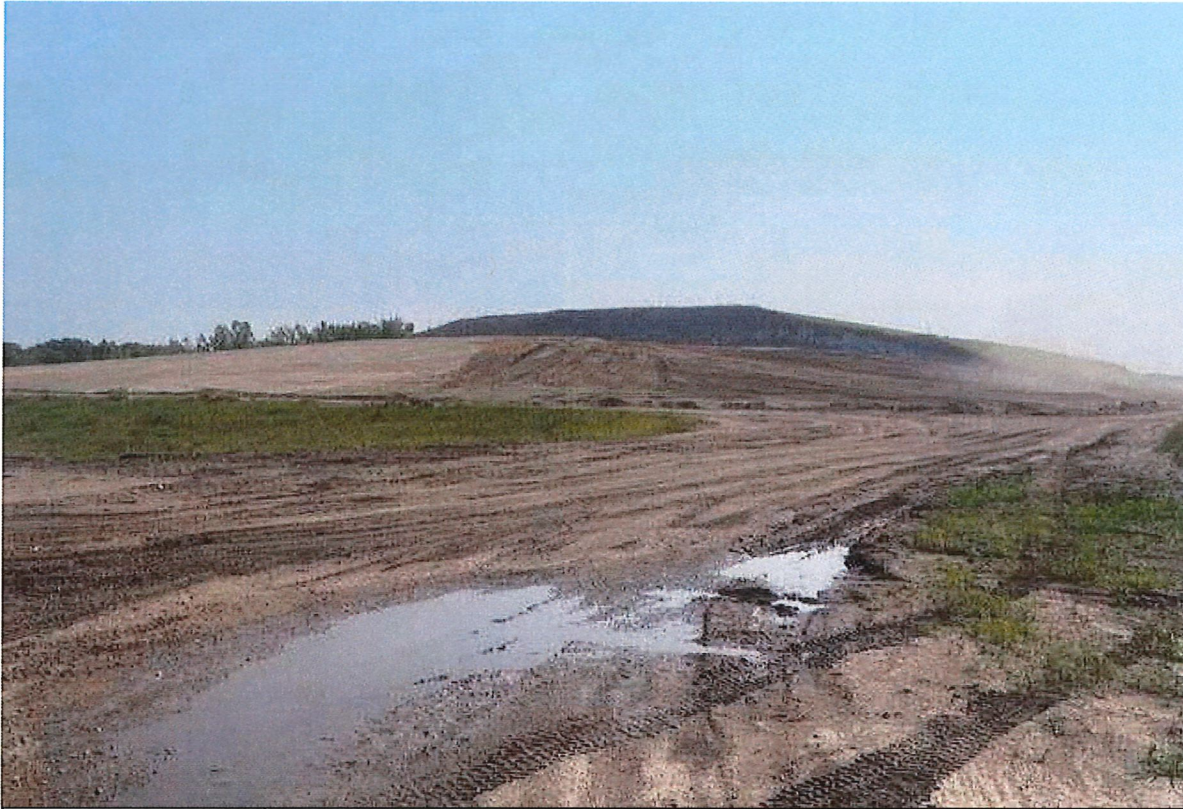
Photo 1	Subgrade grading, looking northeast at landfill.
7/10/2023

To begin subgrade preparation for final cover construction, ash was excavated using an excavator and GPS dozer and was re-placed where fill was needed to achieve the permitted liner grades. Where ash was at liner grades, the ash was over-excavated at least 12 inches. Where additional fill was needed to reach liner grades, common fill was excavated from onsite borrow, hauled to the project area by off-road haul trucks, spread with a GPS dozer in 12-inch loose lifts, and compacted with a vibratory smooth drum roller. At least 12 inches of buffer soil was placed over all ash to protect the final cover geomembrane. At liner grades, rocks larger than 3 inches were removed by hand. The subgrade was then smoothed by back dragging with a skid-steer and rolled with a smooth-drum roller, providing a uniform surface prior to liner deployment.

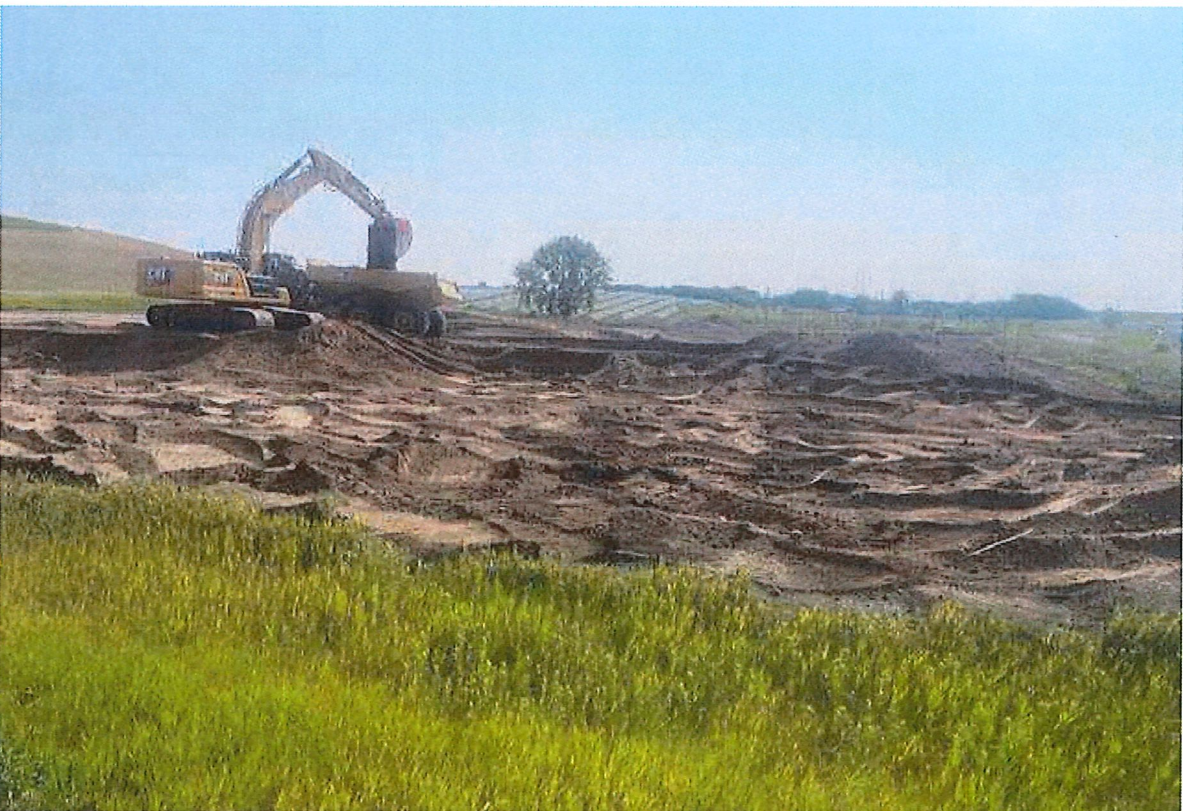
Photo 2	Common fill and buffer excavation from the borrow area; looking southwest.
7/10/2023

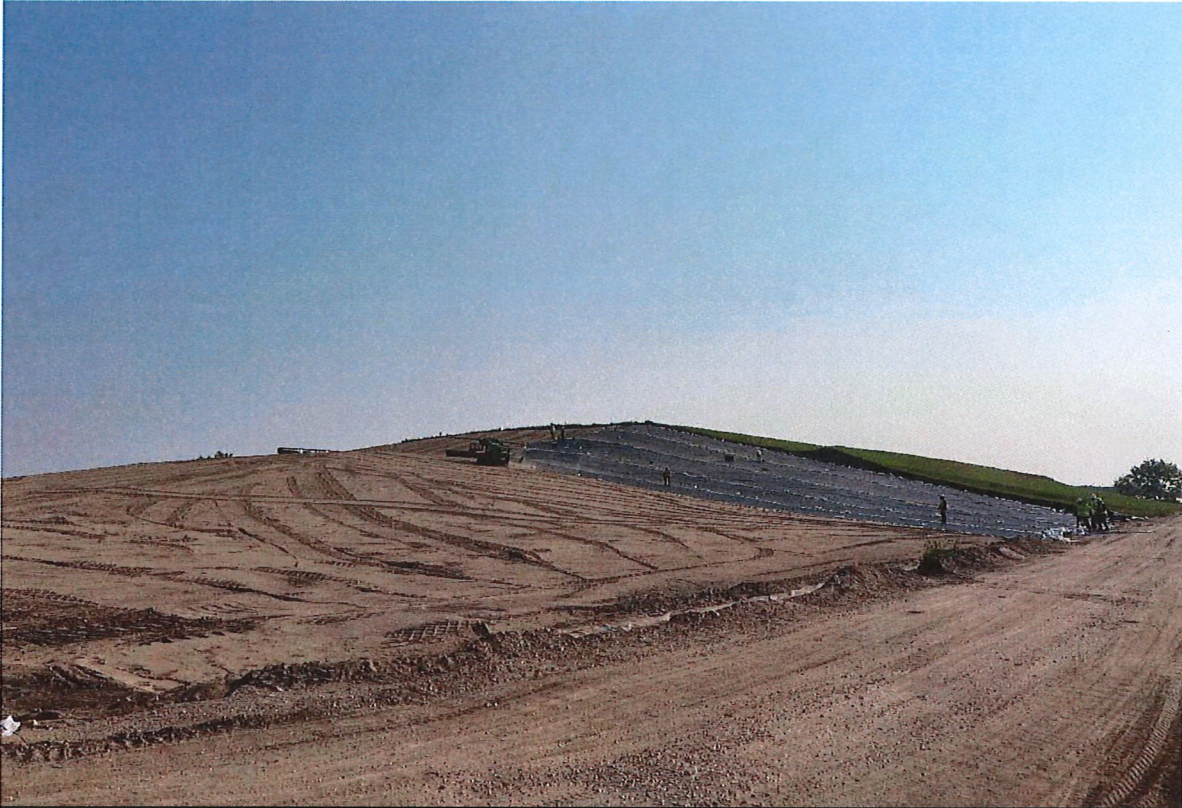
Photo 3	LLDPE geomembrane liner deployment starting on south slope; looking east.
8/29/2023

LLDPE geomembrane seam testing and quality control is discussed in Section 3.2. Panel orientation, panel number, seam, destruct, and repair locations are shown on the As-built Panel Layout Drawings in Appendix C. Geomembrane installation is shown in Photos 3 through 10 in the Construction Photo Log in Appendix A.

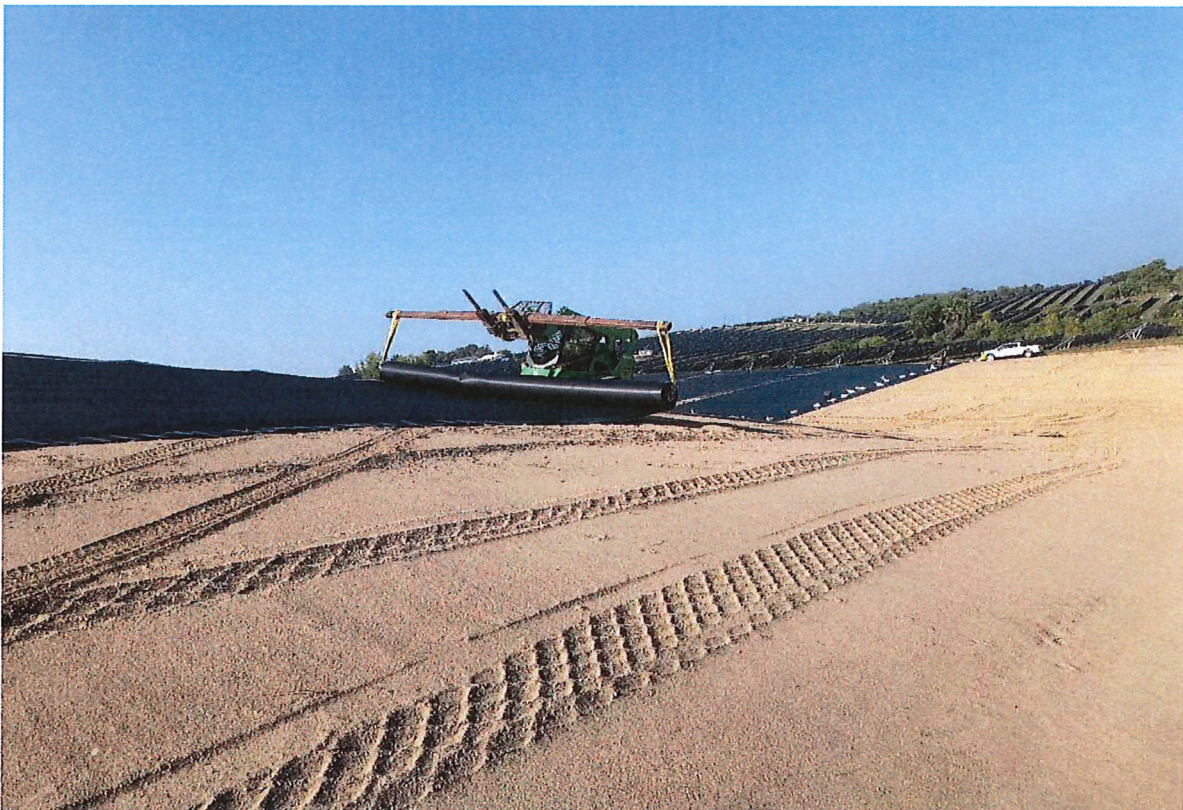
Photo 4	Skid-steer deploying geomembrane over smooth rolled buffer soil.
8/29/2023

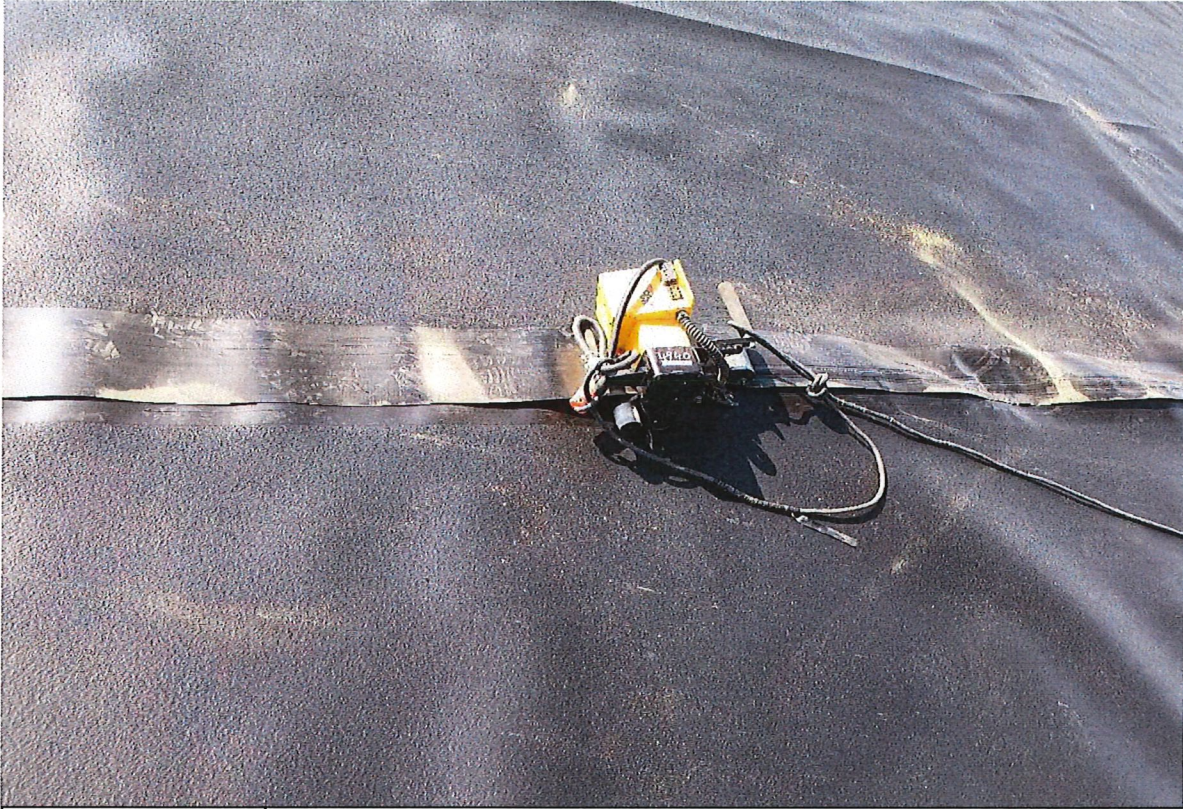
Photo 5	Dual-wedge welding of geomembrane panels
8/29/2023

All seams were non-destructively tested for leaks using either the air-channel test for dual-wedge welded seams or the vacuum box test for extrusion welded seams. Non-destructive testing was completed until each seam achieved passing results; any leaks found through non-destructive testing were repaired and re-tested. Non-destructive testing is included on the Panel Seaming Forms and Repair Forms in Appendix C.

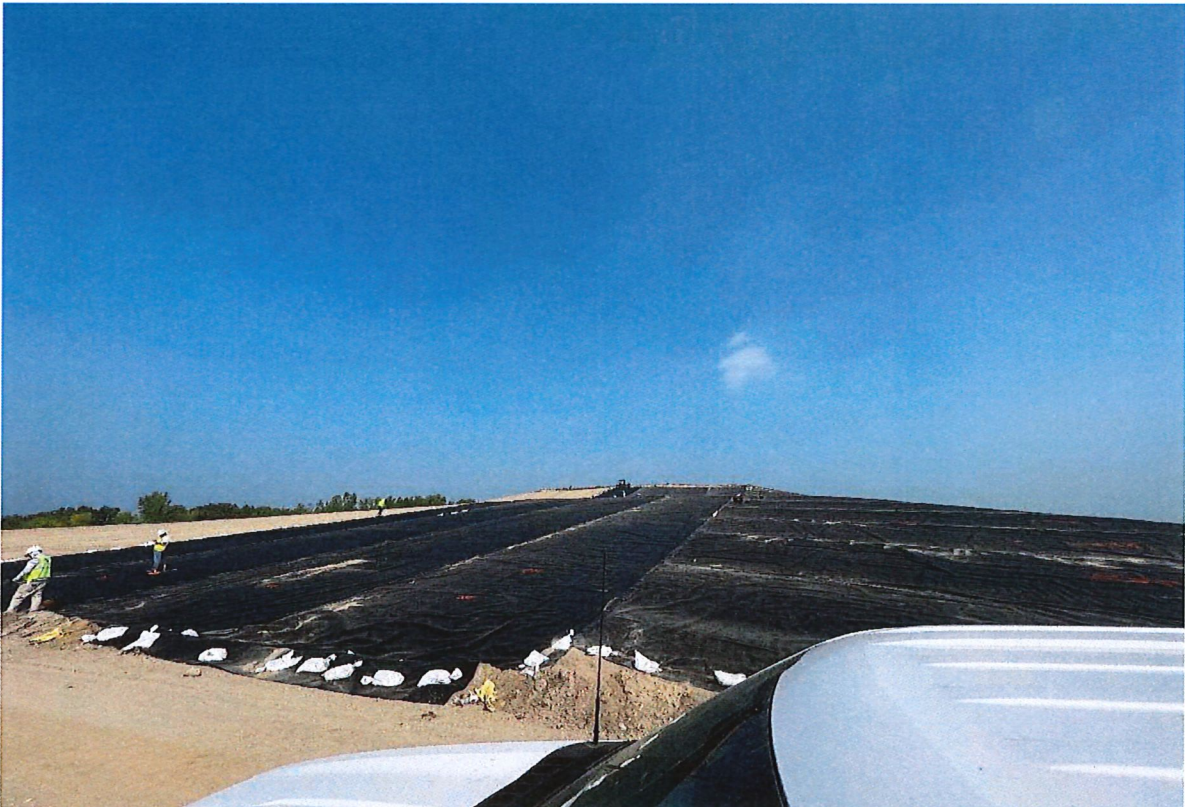
Photo 6	LLDPE geomembrane liner deployment starting on west slope; looking east.
8/30/2023

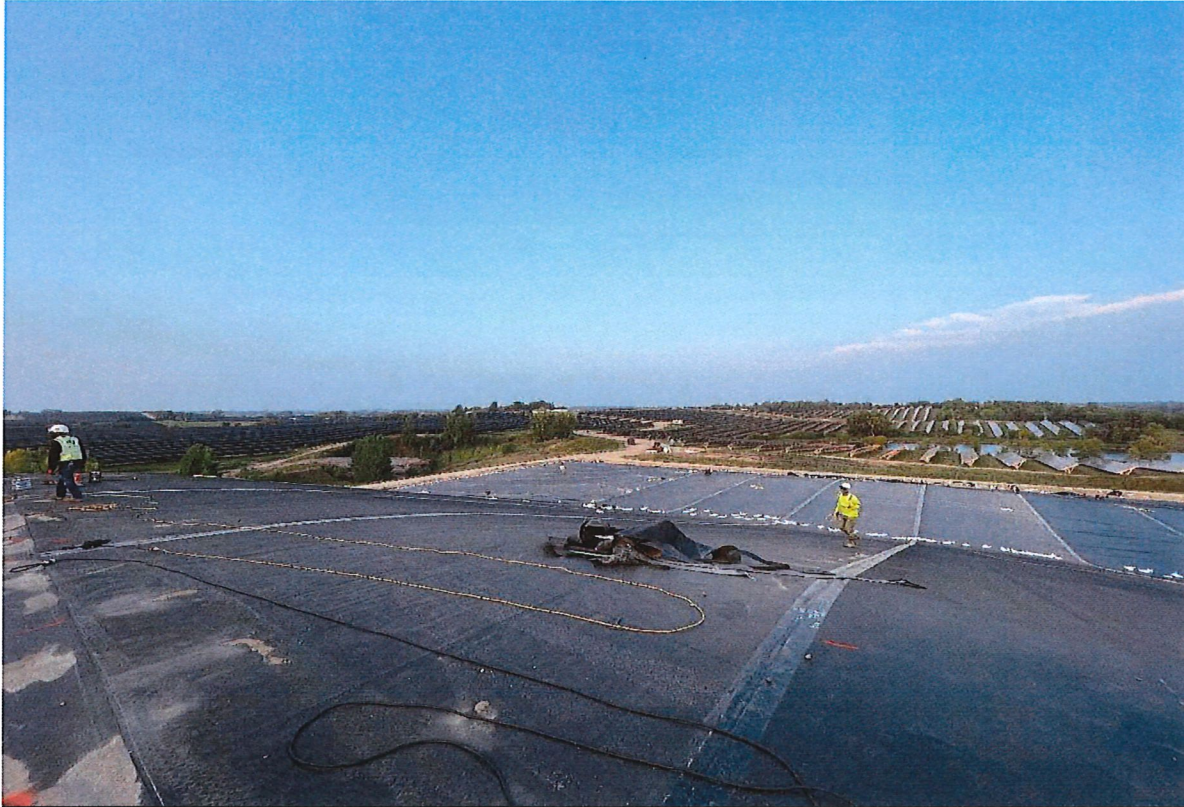
Photo 7	Geomembrane installed over final cover and tie-in; looking southwest.
8/31/2023

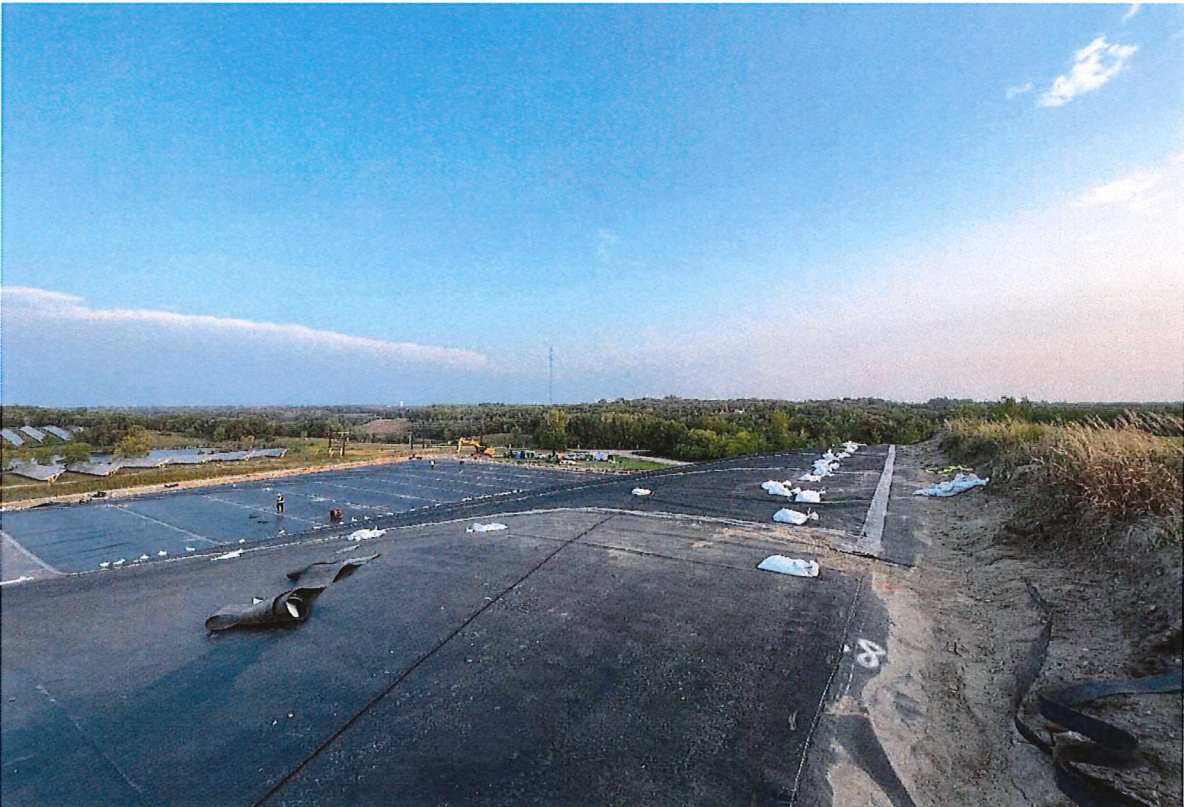
Photo 8	Geomembrane installed over final cover and tie-in; looking northwest.
8/31/2023

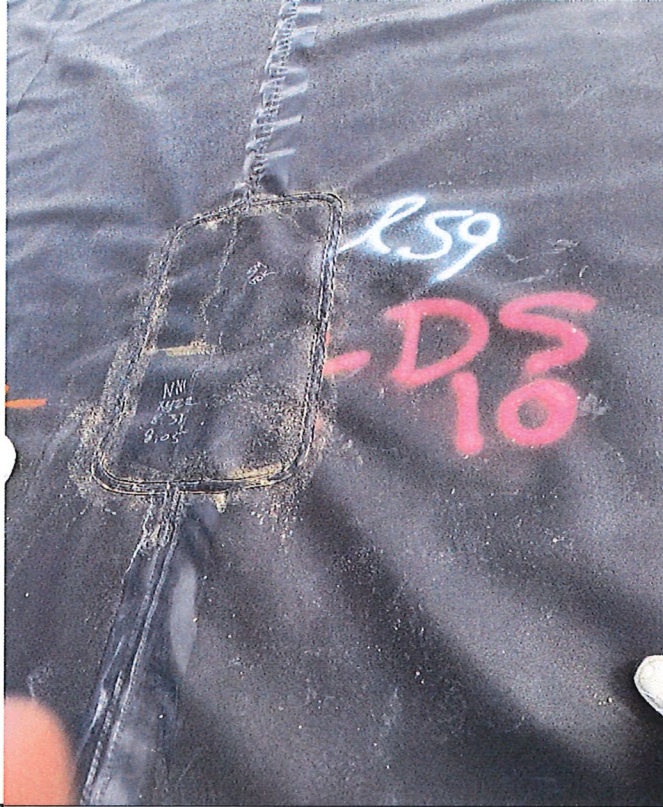
Photo 9	Vacuum tested repair of destruct sample location
8/31/2023

Repairs at seam joints, seam burnouts, rips, tears, or other holes in the geomembrane were mended by extrusion welding a geomembrane patch or cap over damaged areas. Small punctures or manufacturer deformities in the geomembrane were repaired by placing an extrusion bead over damaged areas. All patches, caps, and beads were vacuum tested to verify that the repairs did not leak. Repairs to the geomembrane liner are noted on the As-built Panel Layout Drawing and Repair Forms included in Appendix C.

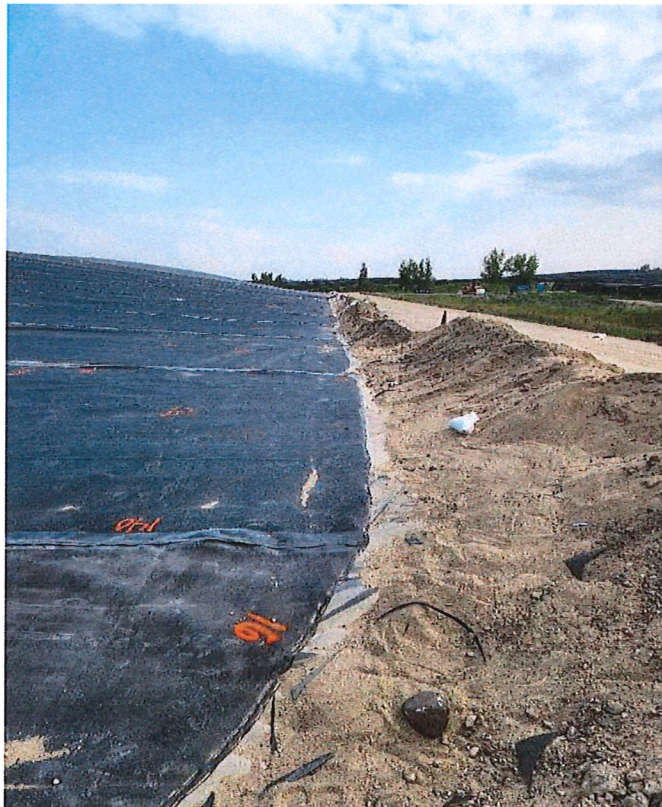
Photo 10	Extrusion welded final cover geomembrane to base liner geomembrane.
8/31/2023

The tie-in to existing final cover was wedge welded where practical. The final cover termination along the toe of the slope was extrusion welded to the existing primary 60-mil high density polyethylene (HDPE) base liner, as noted in the Record Drawings in Appendix F.

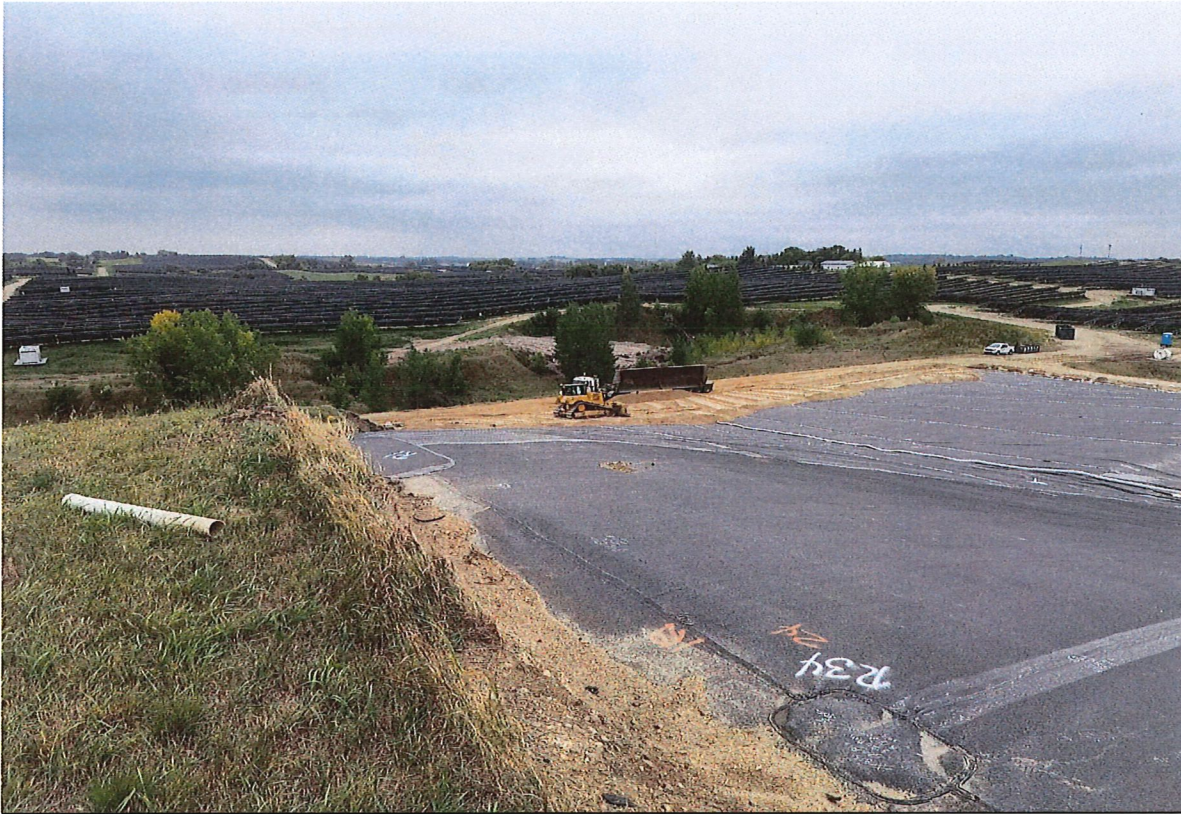
Photo 11	Granular drainage material placement over geomembrane on south slope;
9/5/2023	looking southwest.

To drain infiltrated stormwater over the final cover, 4-inch draitile with filter sock was also installed on top of the geomembrane along the toe of the stormwater berm and around the edges of final, as shown in the Record Drawings in Appendix F. Granular drainage layer placement is shown in Photos 11 and 12 in Appendix A.

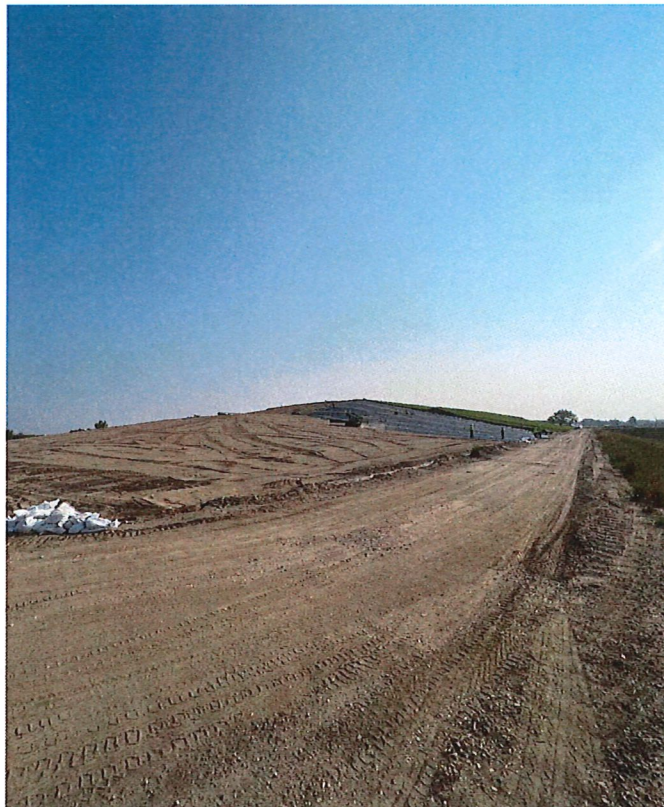
Photo 12	Granular drainage material placement over geomembrane on south slope;
9/5/2023	looking northeast.

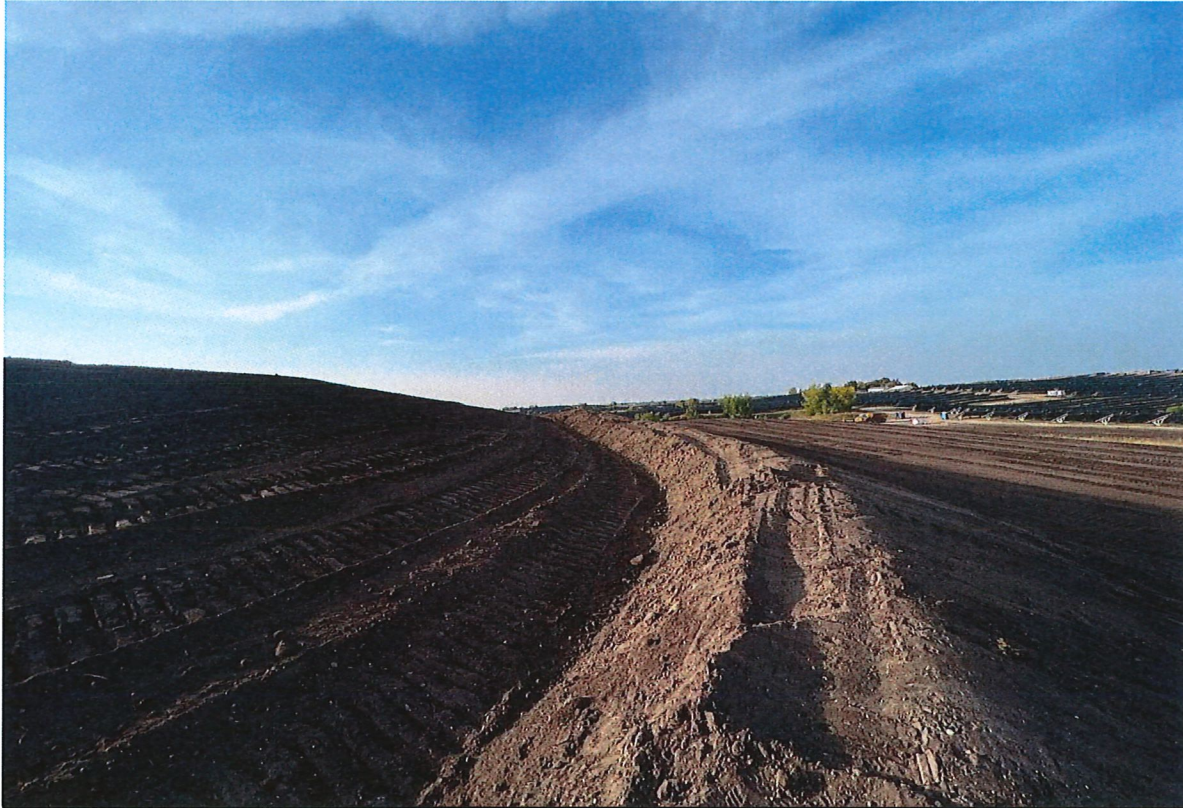
Photo 13	Topsoil rough graded on stormwater berm; looking southwest
9/20/2023

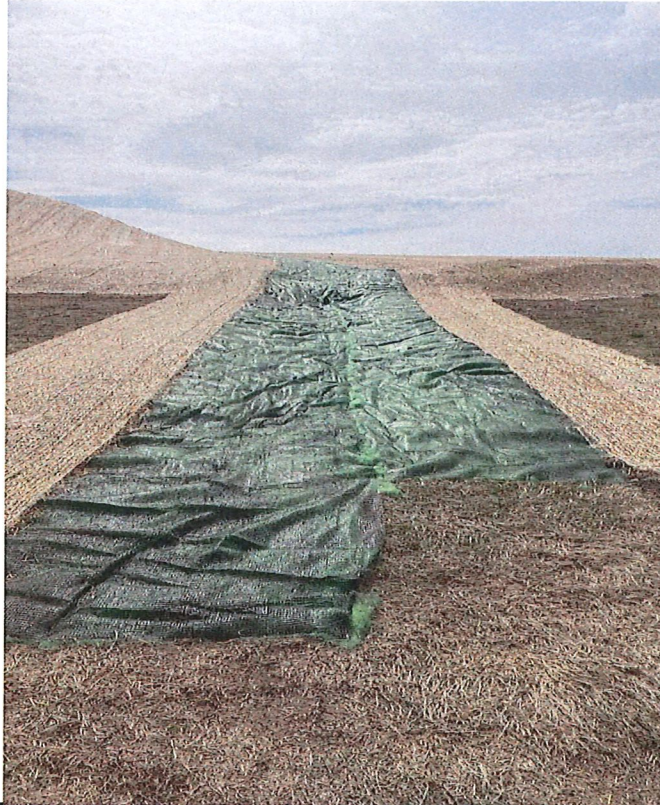
Photo 15	Turf mat placed through north stormwater channel; looking south.
9/25/2023

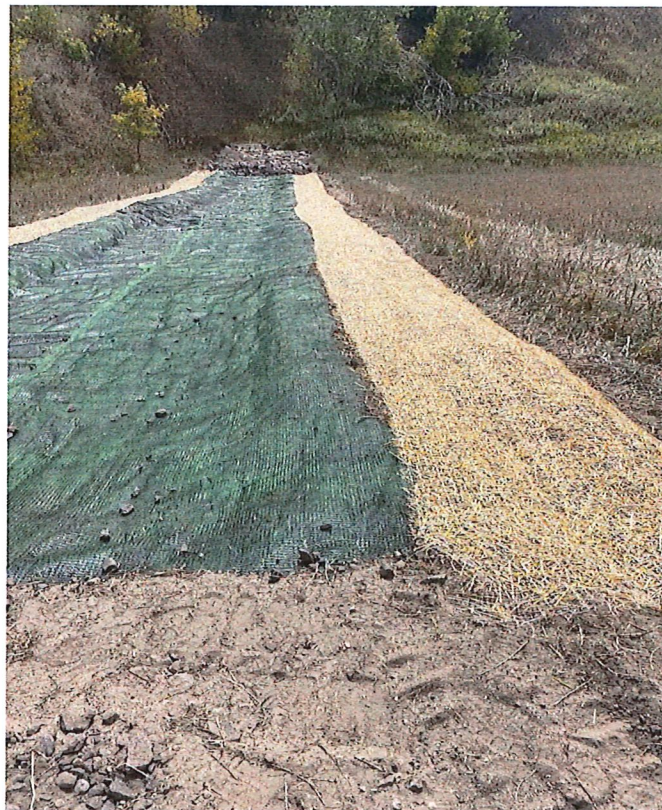
Photo 16	Turf mat placed through south stormwater channel below landfill, rip rap plunge pool at base; looking south.
9/25/2023

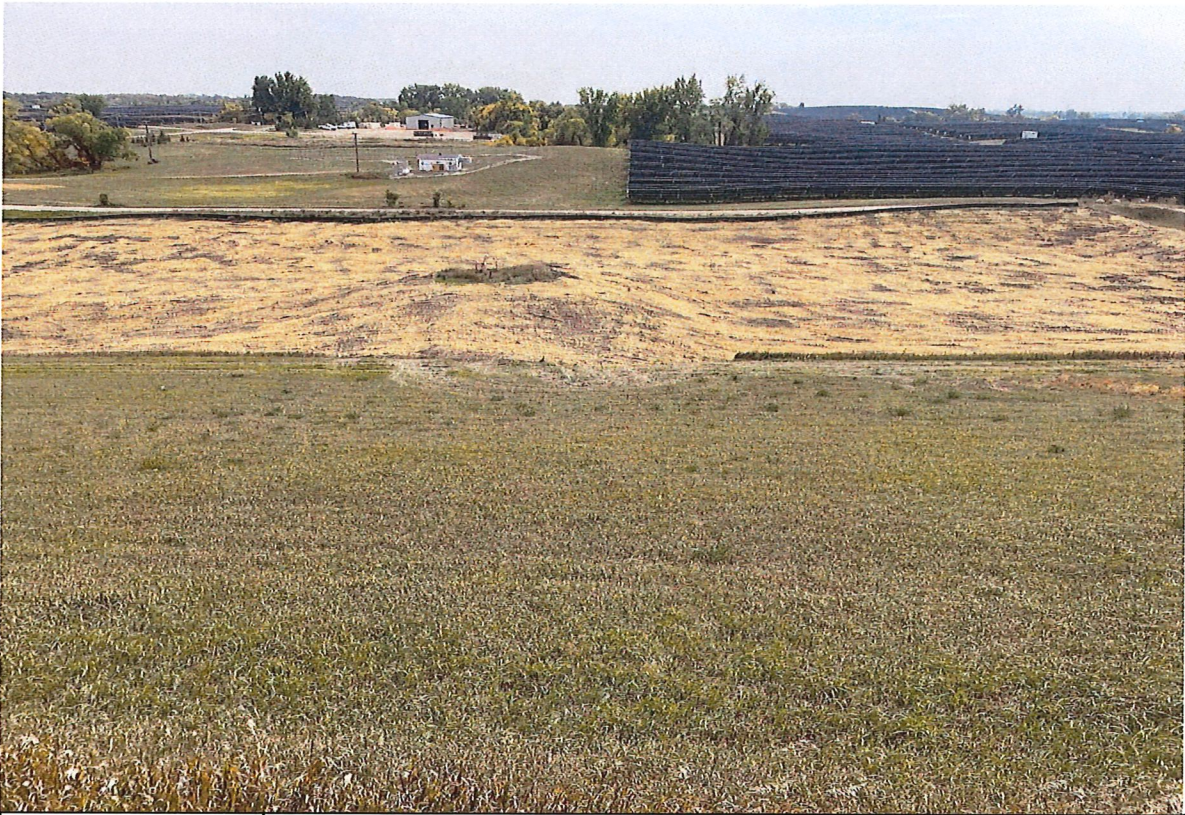
Photo 17	Restored borrow area; looking south.
9/25/2023

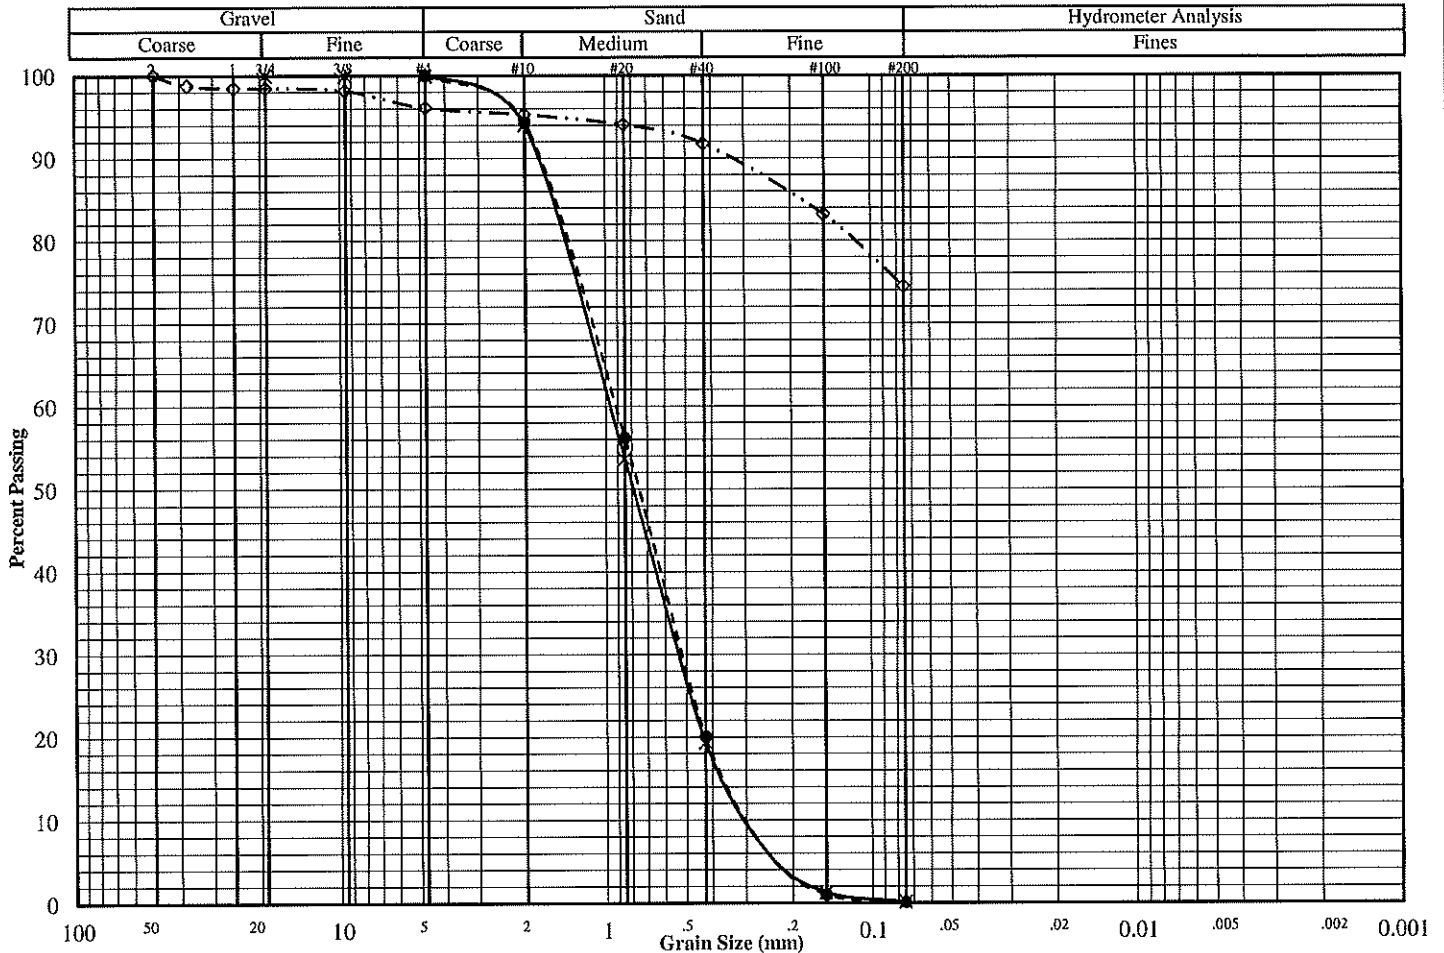
# Grain Size Distribution ASTM D422-16

Location / Boring No.	Sample No.	Depth (ft)	Sample Type	Soil Classification	Note: source topsoil test included in report is crossed out, see topsoil source testing reports for data
*		S-1		Bulk	Sand, medium grained (SP)	
•		S-2		Bulk	Sand, medium grained (SP)	
◇				Bulk	Lean Clay w/ sand and a trace of gravel (CL)
